Laboratoire M.S.M.A.P. SARL

STUDY OF A SWORD WITH GOLD INLAID INSCRIPTION (L.: 57 cm)

Assumed provenance and period: Khorasan, Samanid, 9th -10th century AD.

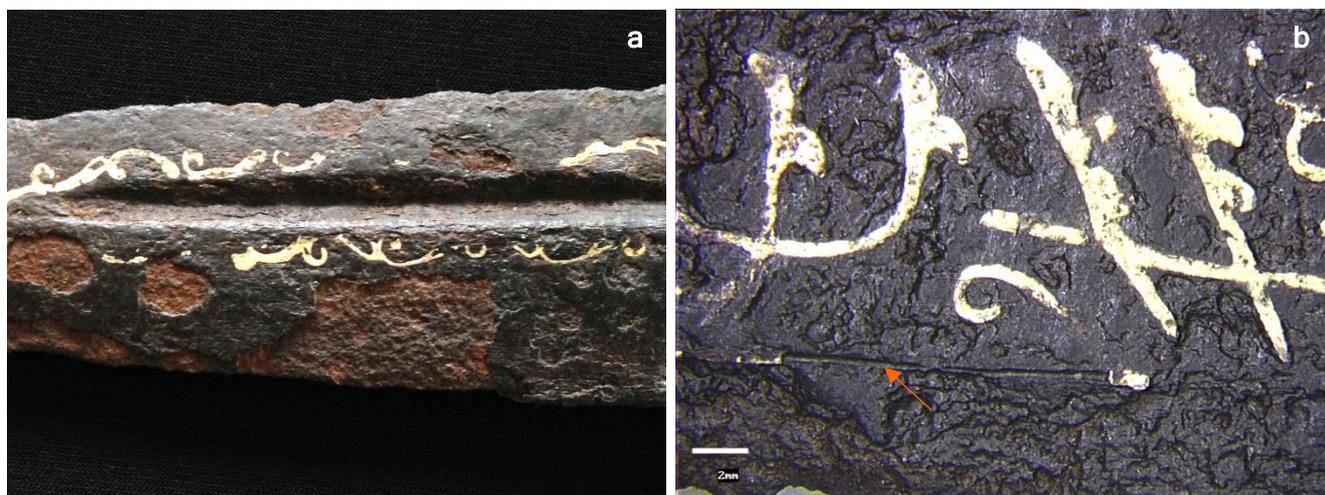
Figure 2: Detail views of the sword (a- photograph, b- stereoscopic microscope, x5, c- X-Ray radiograph of the same area as b-) The square locates Fig. 2b.

The blade is completely covered by layered dark-brown to reddish-brown corrosion products (Fig. 2a) and does not show areas of sound uncorroded metal. It is a grooved blade, with a fuller on each face of the blade. The gold inlaid inscriptions on the blade are partially hidden by these corrosion products (Fig. 2b).

Observations of the degraded inscription show sharp recesses in the blade corrosion products, where the inlays were inserted (Fig. 2b, arrow).

X-Ray radiographs emphasize the very acute outlines of the inlays, under the metal corrosion products (Fig. 2c).

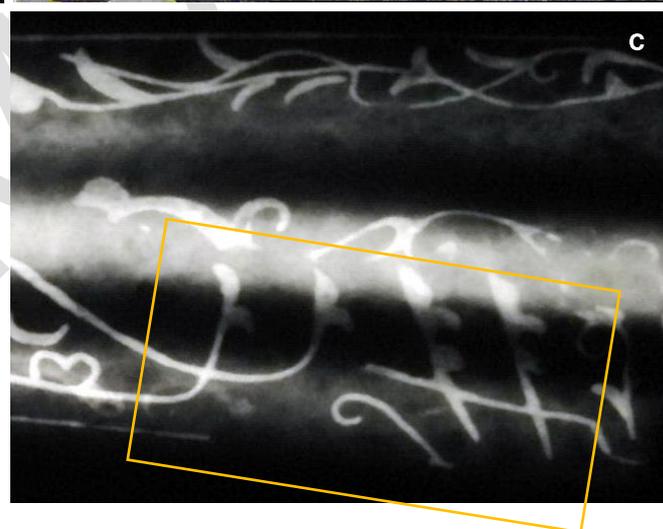
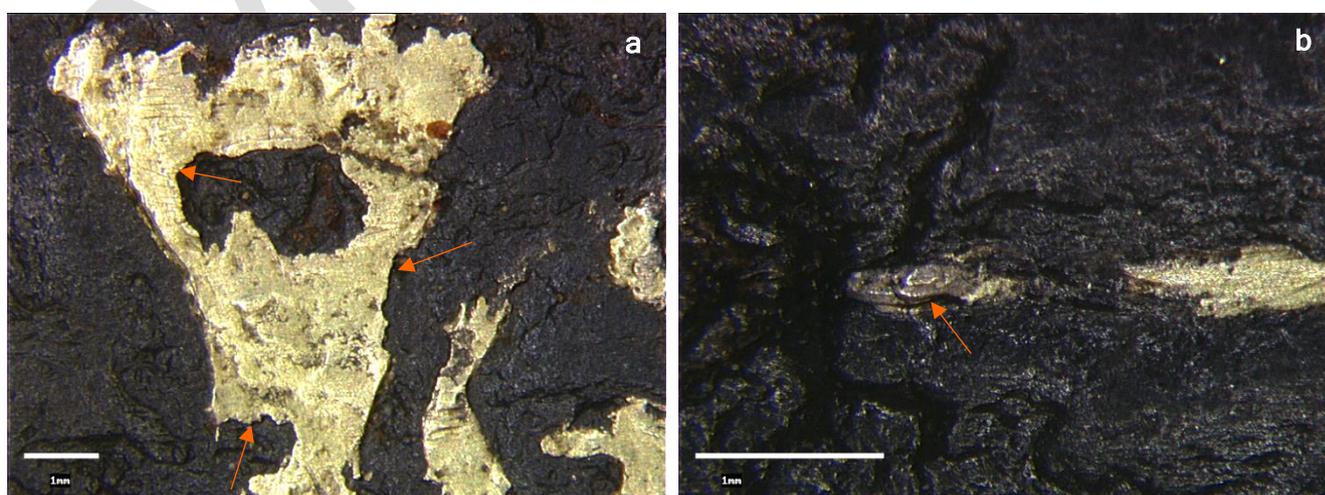
Figure 3: Detail views of the inlaid inscription (stereoscopic microscope, a- x14, b- x31).

The inlays apparently consist of a foil (Fig. 3a) originally inserted in chiseled recesses on the blade surface, but in some places the inlay appears rather as a thick and massive material than as a foil, with a silvery hue (Fig. 3b, arrow).

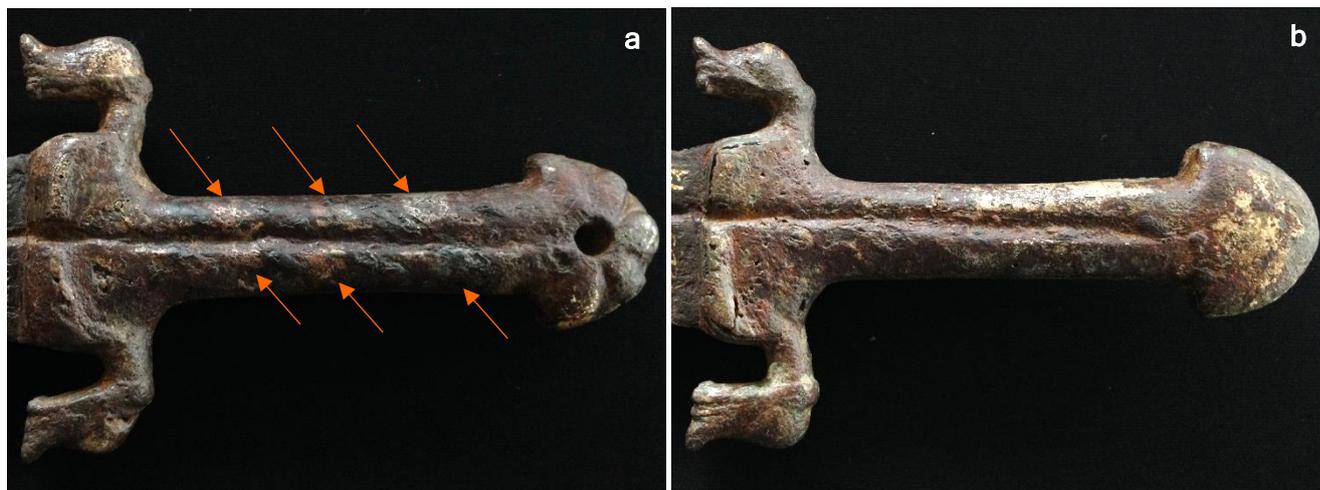
Figure 4: General views of the hilt (a- and b- photographs) and detail of the pommel (c- stereoscopic microscope, x5).

The gilding is degraded and shows abundant brown to greenish corrosion products from the underlying metal (Fig. 4c).

A diagonal banded pattern, alternating gold and dark stripes is perceptible on the front of the grip (Fig. 4a, arrows). This could be the result of a differential wear of the gilding, on a raised pattern. The back is apparently completely gilded (Fig. 4b).

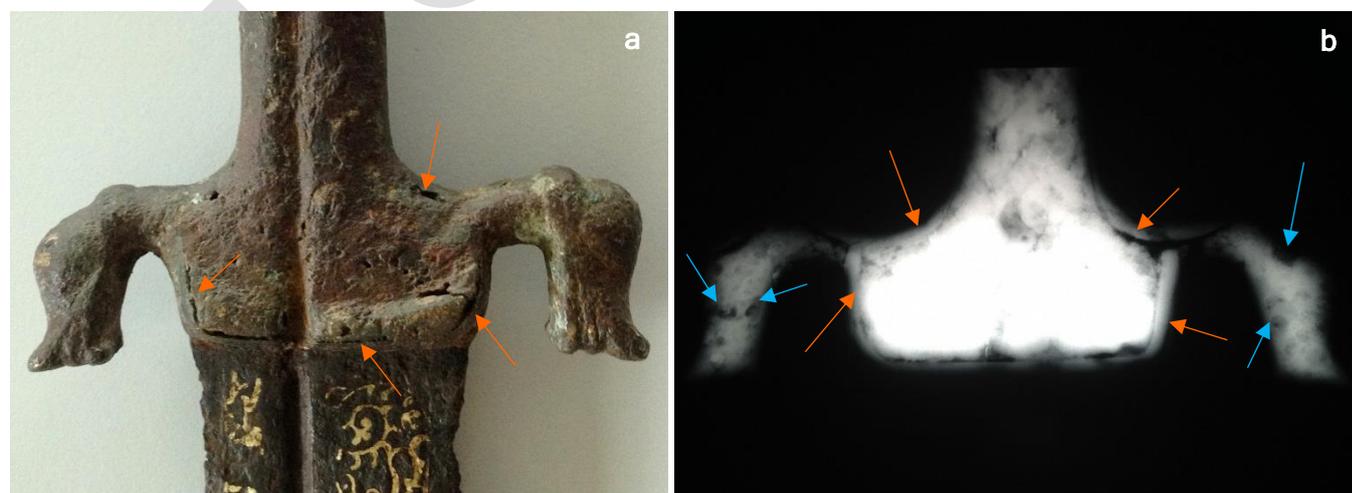
Figure 5: General views of the cross-guard (a- photograph, b- X-Ray radiograph).

The cross-guard shows cracks (Fig. 5a, arrows) suggesting the association of different metallic parts to build the hilt. This peculiar structure is well observed on the X-Ray radiographs (Fig. 5b).

The metal of the hilt shows numerous porosities (Fig. 5b, blue arrows), suggesting a high state of corrosion under a copper alloy metallic casing (Fig. 5b, orange arrows) that tightens the different elements of the hilt up to the pommel.

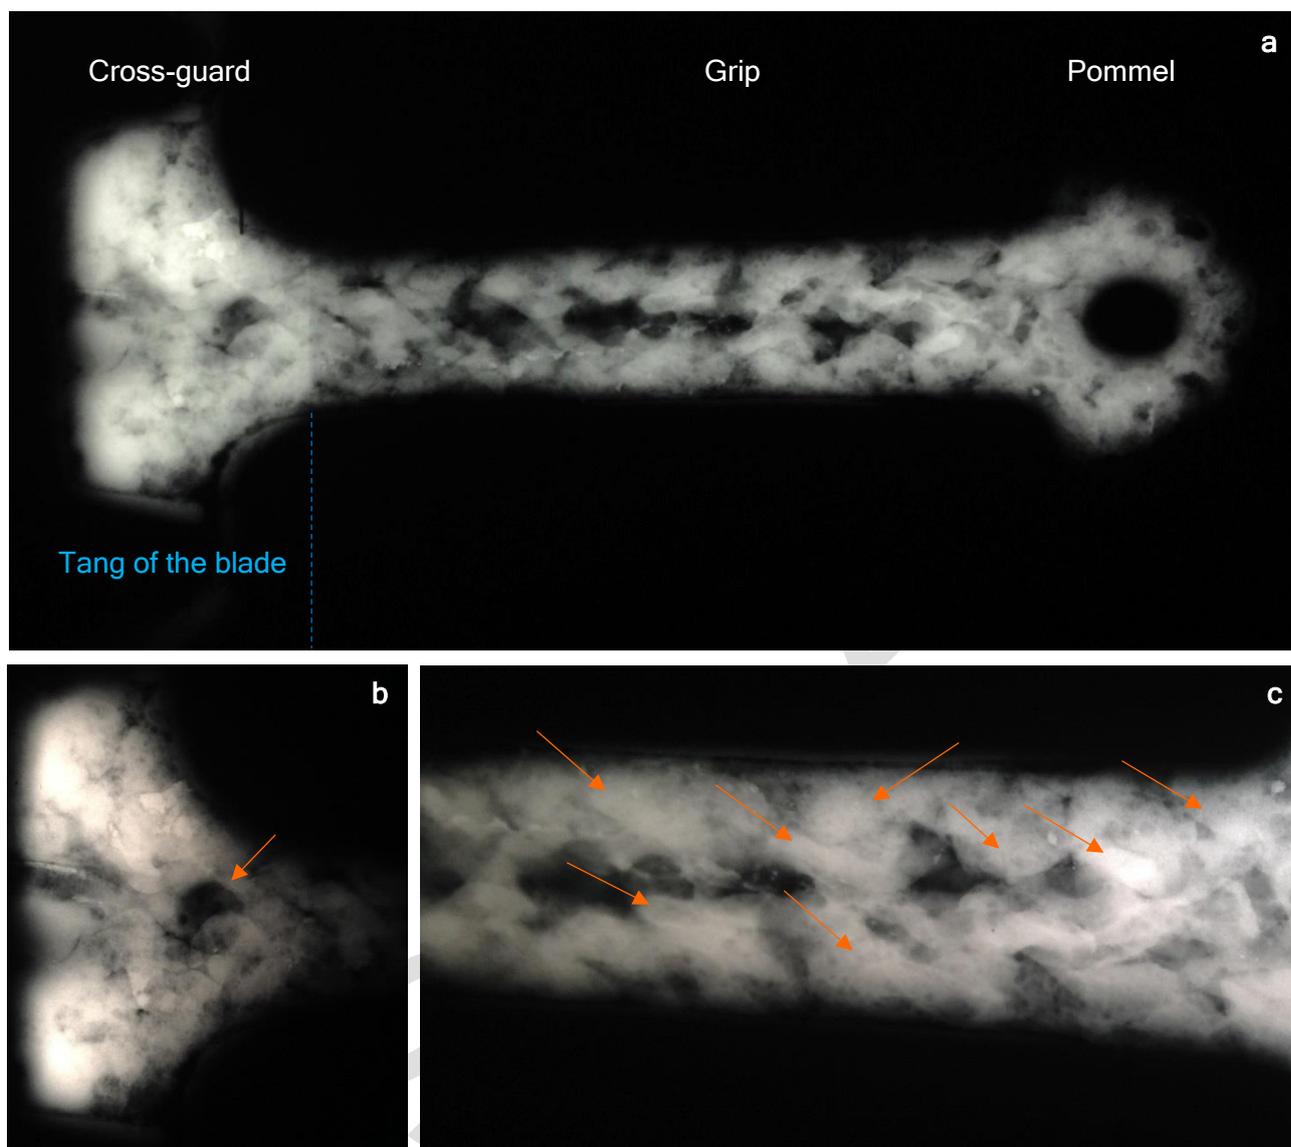
Figure 6: X-Ray radiographs of the hilt (a- general view, b- detail of the tang of the blade inside the grip, c- detail of the grip braid-like structure)

X-Ray radiographs of the hilt (Fig. 6) show a heavily corroded metal, with an oriented or braid-like (?) structure (Fig. 6c, arrows).

The blade has a short and broad tang (Fig. 6a and b), which is inserted in the grip.

A hole in the tang observed on the X-Ray radiographs (Fig. 6b, arrow) could be indicative of a riveted fixation observed on early Islamic swords (1).

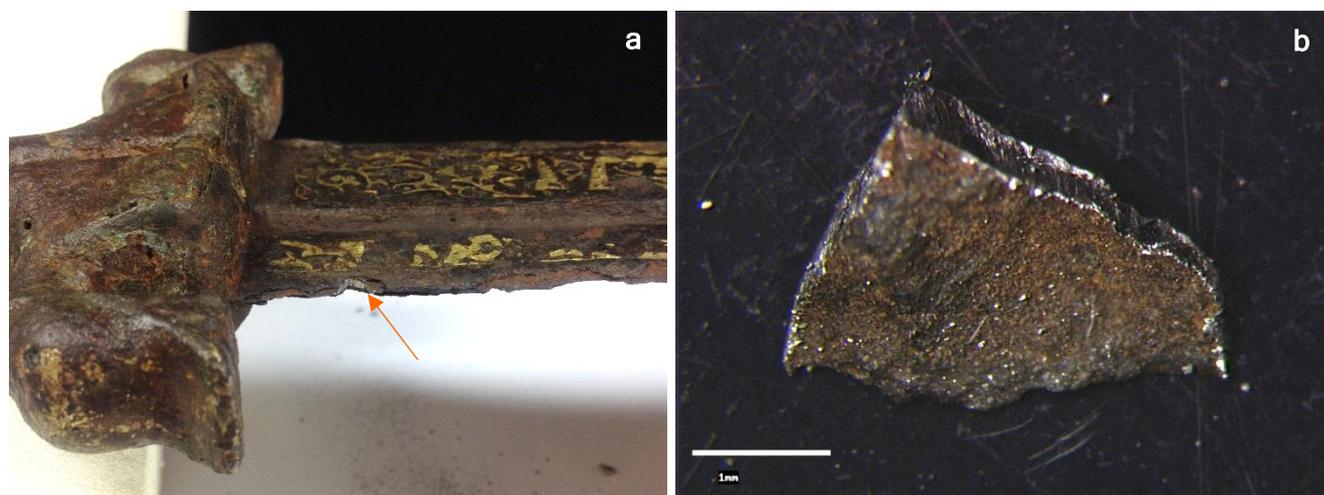
Figure 7: Detail views of the blade metal sample (a- photograph, b- and c- stereoscopic microscope, x23).

The metal was sampled at the base of the blade, near the cross-guard (Fig. 7a, arrow). Sawing shows a white metal, under the layered corrosion products.

The metal sample (P1) shows on one side the brownish-red corrosion products (Fig. 7b) and on the other side a bright white flaky material (Fig. 7c).

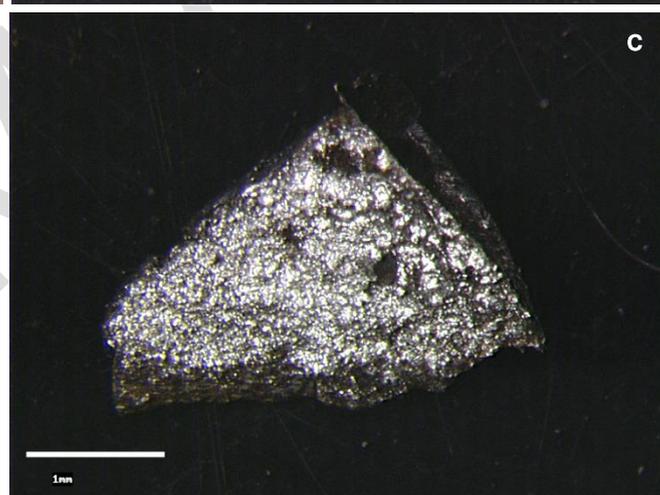
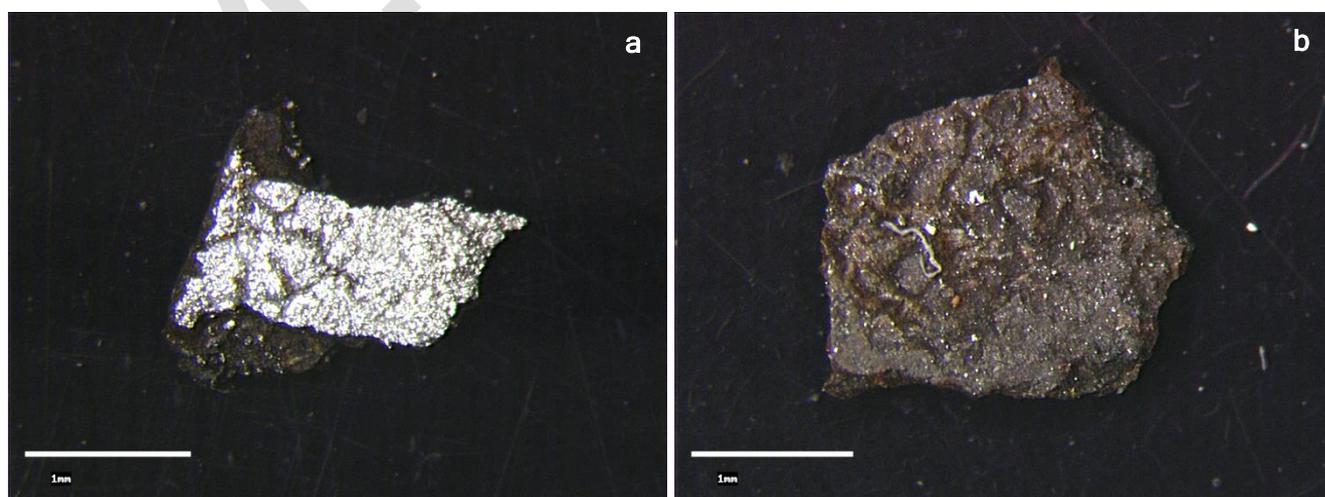
Figure 8: Detail views of the corrosion products samples (a- C1 and b- C2, stereoscopic microscope, x42)

One of the fragments (C1) exhibits the white flaky material on one side (Fig. 8a) and corrosion products on the other side. The other fragment (C2) is plain corrosion products and one of its side (Fig. 8b) corresponds to the present corroded blade surface.

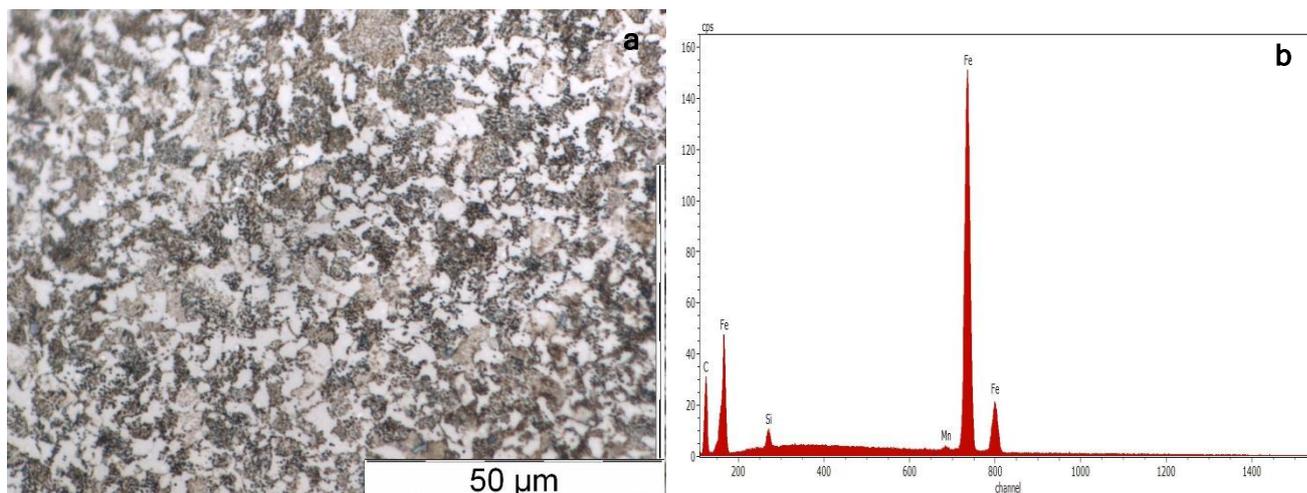
Figure 9: Detail view (a- inverted metallographic microscope, x500) and global EDX analysis spectrum (b-) of the blade metal.

The blade is made out of low carbon steel as evidenced from the ferrite-pearlite microstructure (Fig. 9a and Fig. 10b).

Silicon is detected (about 1.6%) alloyed to the iron (Fig. 9b), and manganese (about 0.7%). This last element is also observed as elongated manganese sulphide inclusion with copper traces (Fig. 10a) parallel to the flat of the blade (Fig. 10b, arrows).

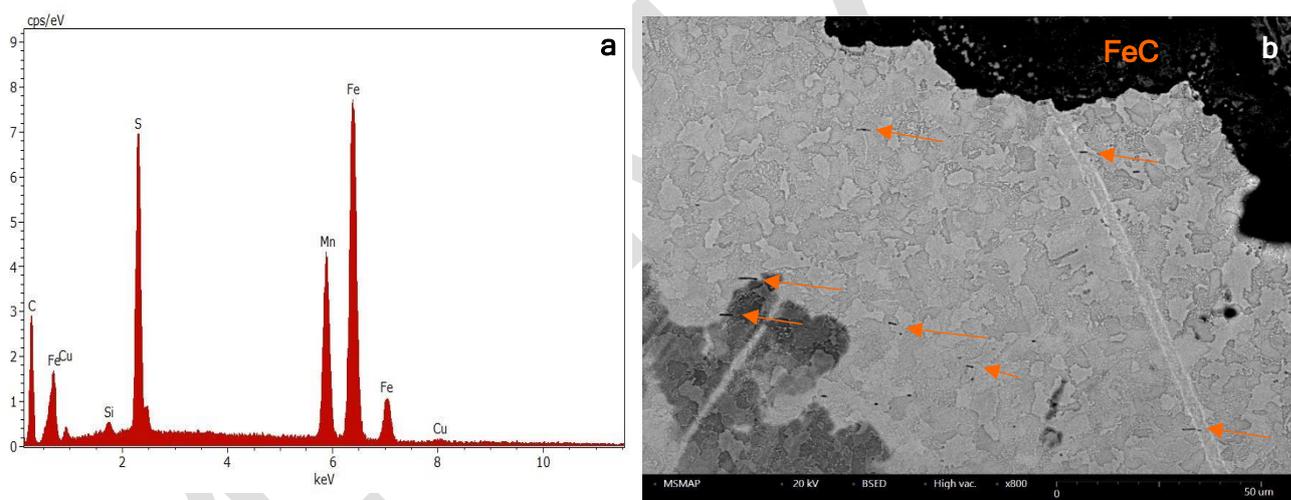
Figure 10: EDX analysis spectrum of the elongated manganese sulphide inclusions (a-) and detail views (SEM, BSE, b- x800, c- x2000) of the blade metal and corrosion.

The elongated manganese sulphide inclusions and the fine-grained homogeneous equiaxed ferrite-pearlite structure are indicative of a final annealing process of the steel after a probable hammering decarburization of a high carbon steel (crucible steel?).

The corrosion (Fig. 10b and c, FeC) develops in complex multilayered products which will be studied later in this report. A "ghost" microstructure of the steel - mainly pearlite- is visible throughout the corrosion layers (Fig. 10c, blue arrows).

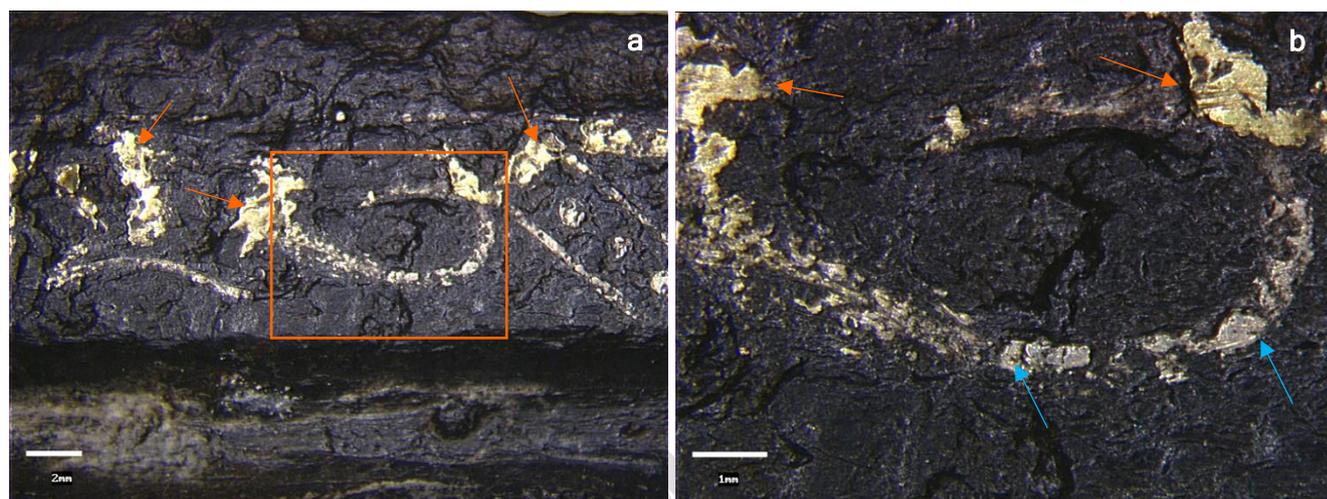
Figure 11: Detail views of the inlaid inscription (stereoscopic microscope, **a-** x 5, **b-** x14) and X-Ray radiograph (**c-**) of the same area as (**a-**). The boxes locate Fig. 12b.

The inlaid inscriptions have an overall golden colour, but as previously observed (see Fig. 3a), some exhibit a silver-coloured material (Fig. 11, blue arrows) under a golden layer or foil (Fig. 11, orange arrows) that slightly detach from the surface.

The inlays are partly covered by the steel corrosion products from the blade; but X-Ray radiograph (Fig; 11c) reveals a very good state of preservation.

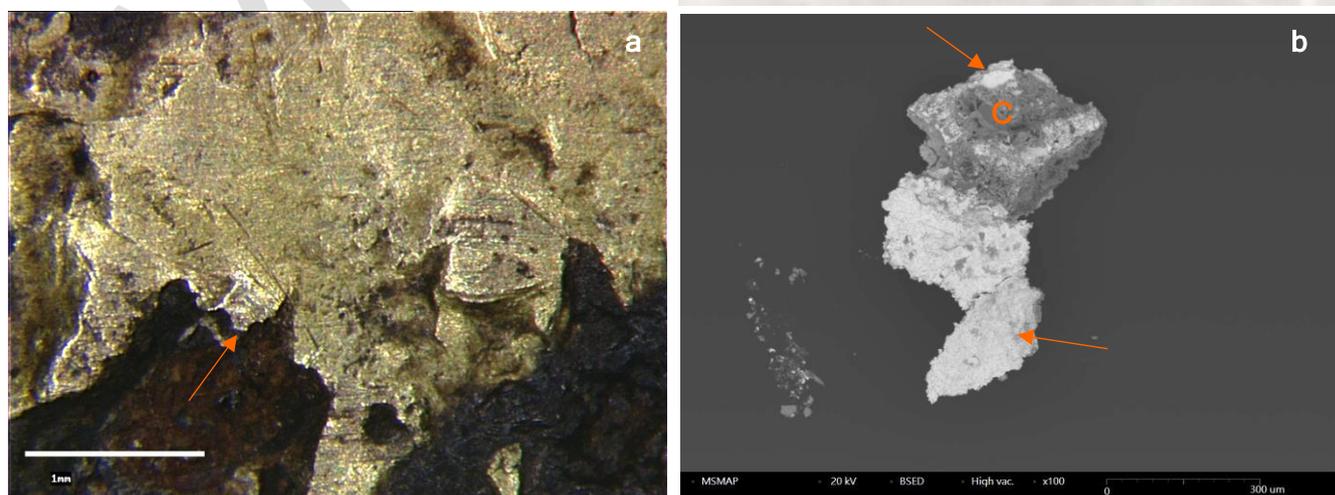
Figure 12: Localization (**a-** stereoscopic microscope, x30) and detail view (**b-**, SEM, BSE, x100) of Sample P2 of gold coloured inlay.

A fragment of the gold-coloured inlay was sampled (Fig. 12, arrows). It peels-off the corroded blade surface as a thick gold foil mixed with steel corrosion products (Fig. 12b, C).

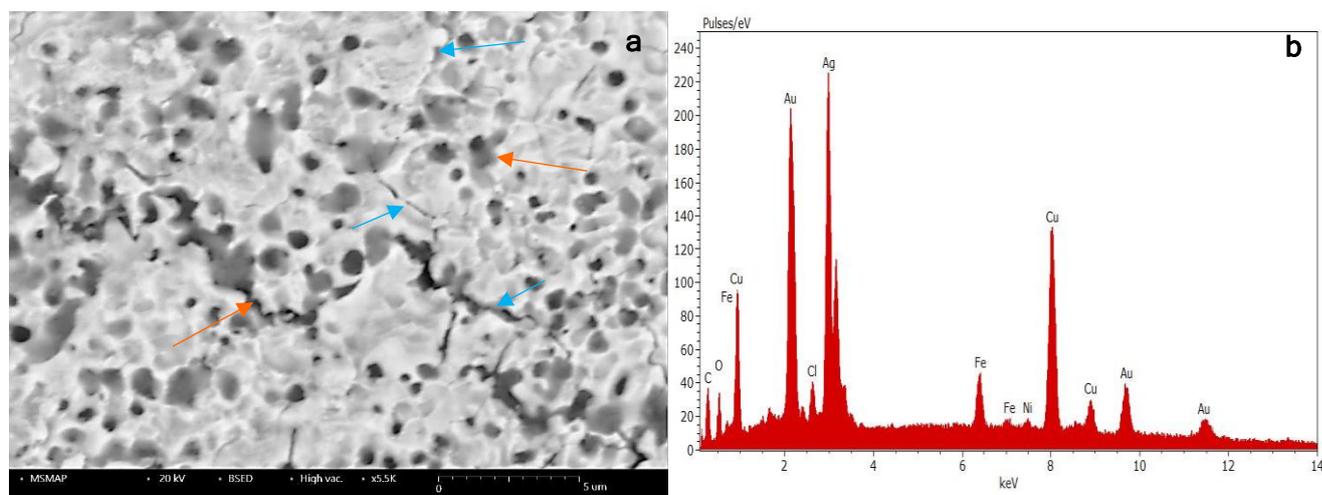
Figure 13: Detail view of the gold foil (a- SEM, BSE, x5500) and EDX analysis spectra of the metal (b-) and the products in contact with the metal (c-). Sample P2.

The metal (Fig. 13b) comprises of a ternary alloy of silver (Ag), gold (Au) and copper (Cu). Low Iron (Fe) and chlorine (Cl) are also detected, and traces of nickel (Ni).

High magnification observation of the gold foil (Fig. 13a) reveals an alveolar or spongy structure, which cavities are partly filled with an iron-rich material (Fig. 13a, orange arrows and 13c).

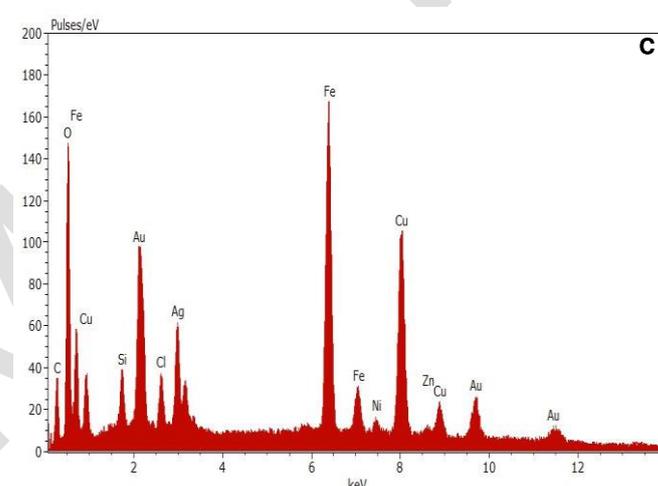
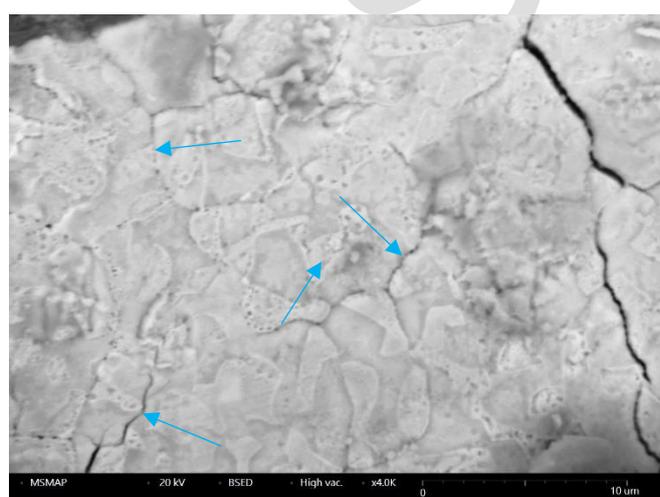
The gold foil can have a more massive aspect, with a visible granular structure and some hollowing at the grain boundaries (Fig. 14, arrows), which is observed also on the other fragment (Fig. 13a, blue arrows).

This granular structure suggests a final annealing of the inlaid metal.

These grain boundaries hollowing-out correspond to an intergranular depletion of the less stable elements from the alloy (copper, silver). This phenomenon is rather indicative of a natural long-term degradation of the gold foil.

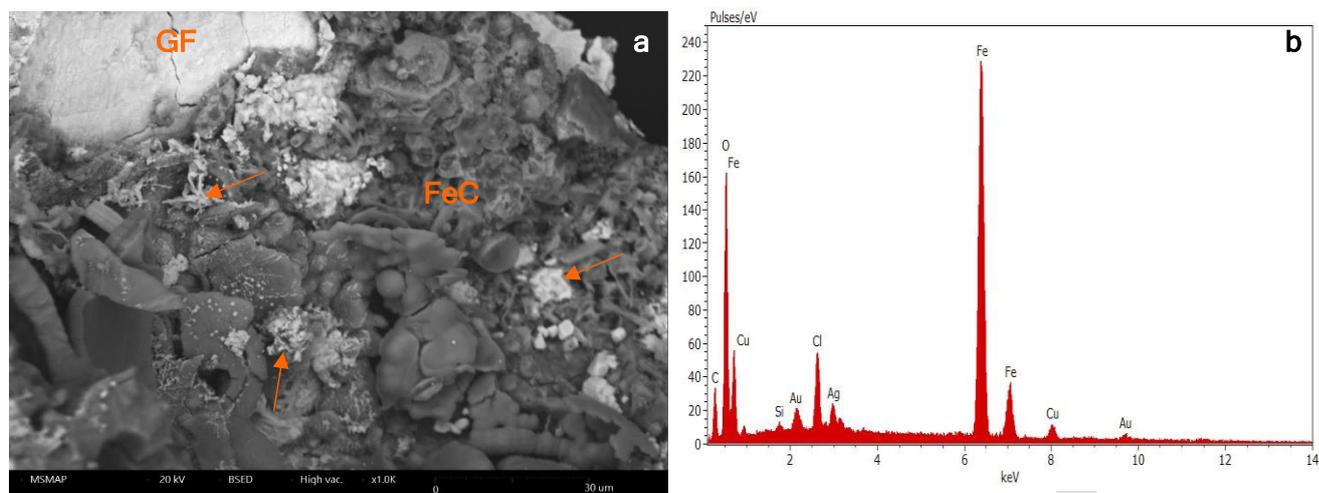
Figure 15: Detail view (a-, SEM, BSE, x1000) of the corrosion products in contact with the gold foil and EDX analysis spectra of the iron corrosion products (b-) and silver corrosion products (c-). Sample P2.

Iron oxides and chlorides massively develop as steel corrosion products (Fig. 15a, **FeC**) and partly cover the gold foil (Fig. 15a, **GF**) as previously observed (see Fig. 12).

Silver chlorides (Fig. 15a, arrows, and Fig. 15c) are present inside the steel corrosion products.

These various corrosion phenomena (grain boundary depletion in the gold foil, iron oxide and chloride, silver chloride crystallization) are well developed and seem to occur simultaneously.

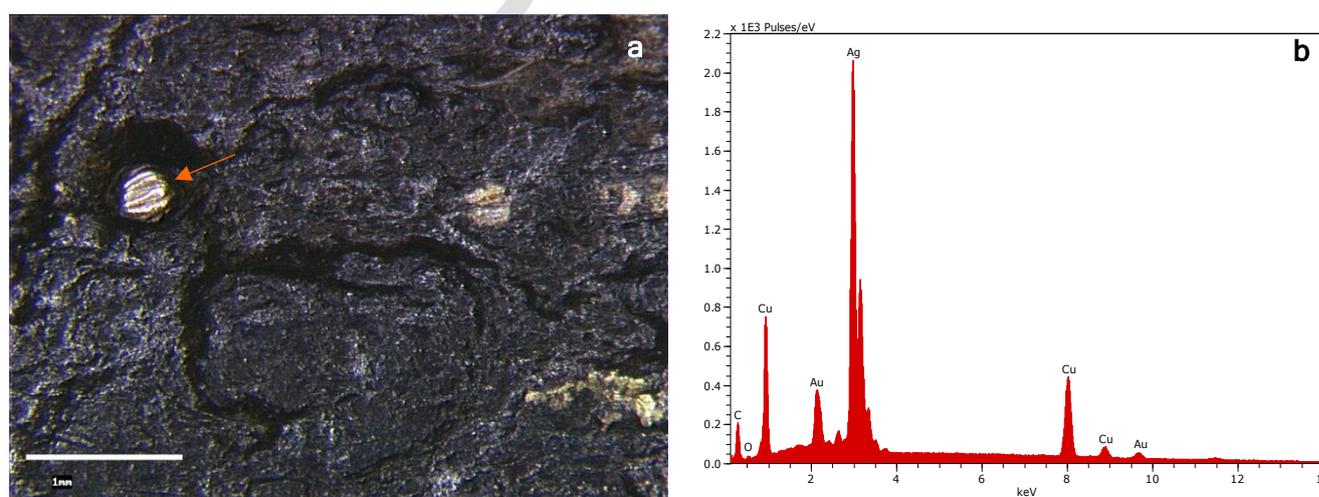
Figure 16: Localization (a-, stereoscopic microscope, x 26) of Sample P3 on the blade and global EDX analysis spectrum of the alloy (b-).

A massive sample of the silver-coloured material visible in places under the gold foil was taken from the inlaid inscription (Fig. 16a, arrow).

The material consists of a ternary alloy of 64% silver, 27% copper and 9% gold. It has a two-phase dendritic structure.

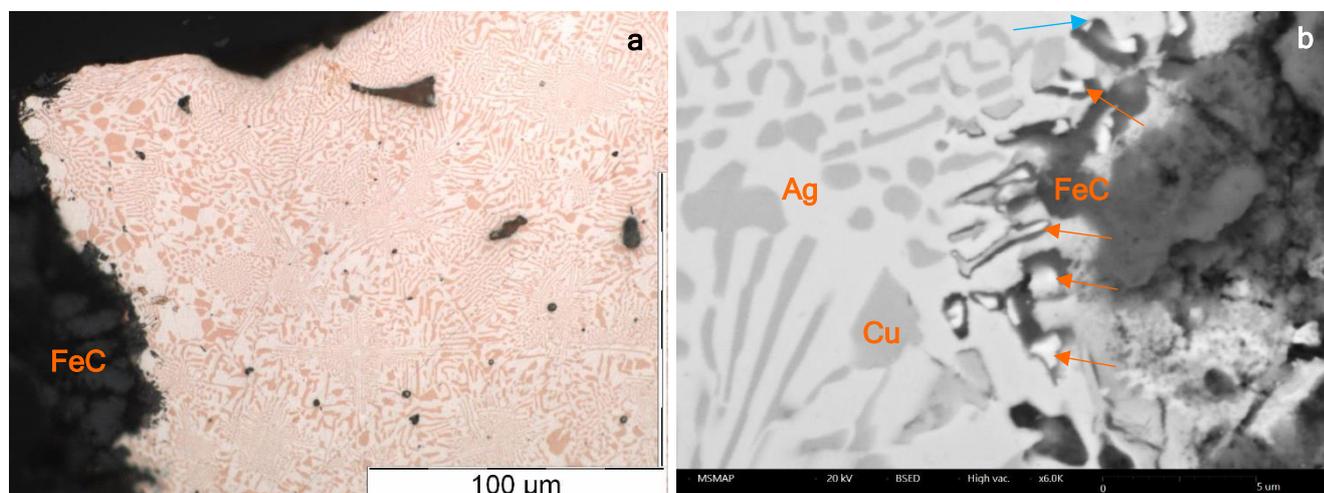
Figure 17: Detail views of sample P3 microsection (**a**-, metallographic microscope, x500, **b**- SEM, BSE, x6000) and EDX analysis spectrum of the gold-enriched phase inside the copper-depleted areas. Sample P3.

The two-phase metal comprises of a white silver-rich (Fig. 17b, Ag) and a pink copper-rich phase (Cu). Both phases contain gold. Some iron and nickel-rich inclusions are observed inside the alloy.

The metal surface shows a preferential corrosion of the copper-rich phase, inducing the depletion of copper (Cu) leaving a gold-enriched phase (Fig. 17b, orange arrows) inside the depletion-induced porosities.

Steel corrosion products from the blade (Fig. 17a and b, **FeC**) are in direct contact with the alloy and partly fill the porosities.

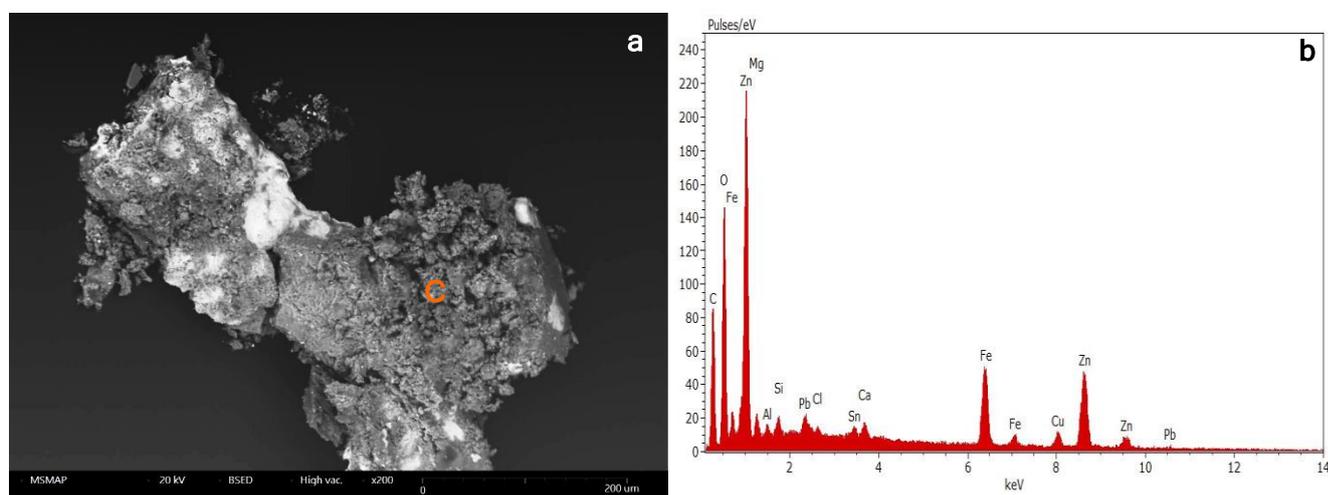
Figure 18: View of sample P4 (a-, SEM, BSE, x200) and EDX analysis spectrum of the corrosion products (b-).

The metal of the hilt has not been directly sampled, but the corrosion products from the hilt surface observed in sample P4 (Fig. 18a, C and Fig. 18b). Iron (Fe), zinc (Zn), copper (Cu) and tin (Sn) are detected indicating the use of a copper-based alloy very probably a leaded brass with some tin (?).

As zinc, lead and tin are not detected - at this level- in the blade corrosion products, they are characteristic of material constituting the hilt.

Magnesium, aluminum and silicon can originate from sedimentary material from the burying environment incorporated in the corrosion products.

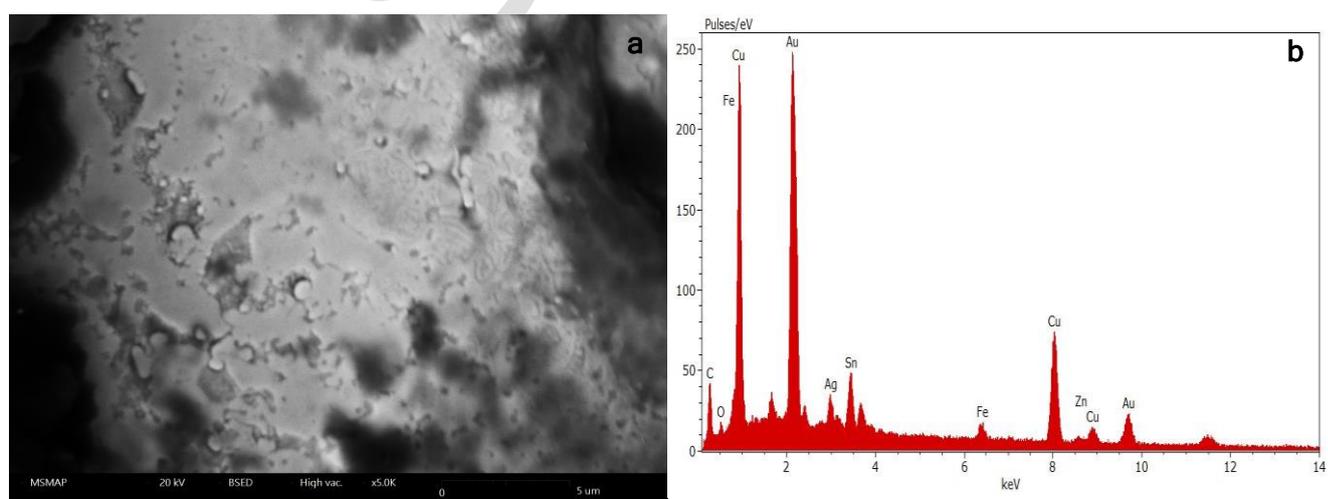
Figure 19: View of sample P4 (a-, SEM, BSE, x5000) and EDX analysis spectrum of the metal (b-).

Analysis of a fragment of the gold foil on the hilt (Fig. 19a) detects a gold (Au) -copper (Cu) - silver (Ag) and tin (Sn) alloy (Fig. 19b).

Traces of iron (Fe) and zinc (Zn) are present, which could come respectively from the blade and from the hilt corrosion products.

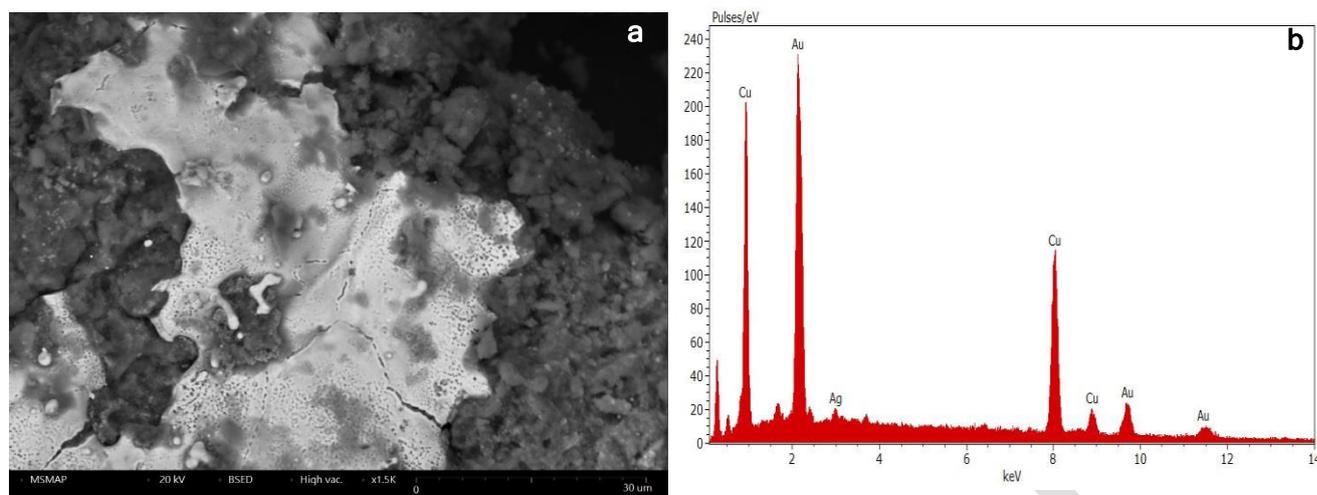
Figure 20: View of sample P4 (a-, SEM, BSE, x1500) and EDX analysis spectrum of the corrosion products (b-).

Another fragment of gold foil was analyzed. The gold seems to have a different composition, with gold (Au) mainly alloyed to copper (Cu) and only trace of silver (Ag) and no tin. This suggests several phases of gilding.

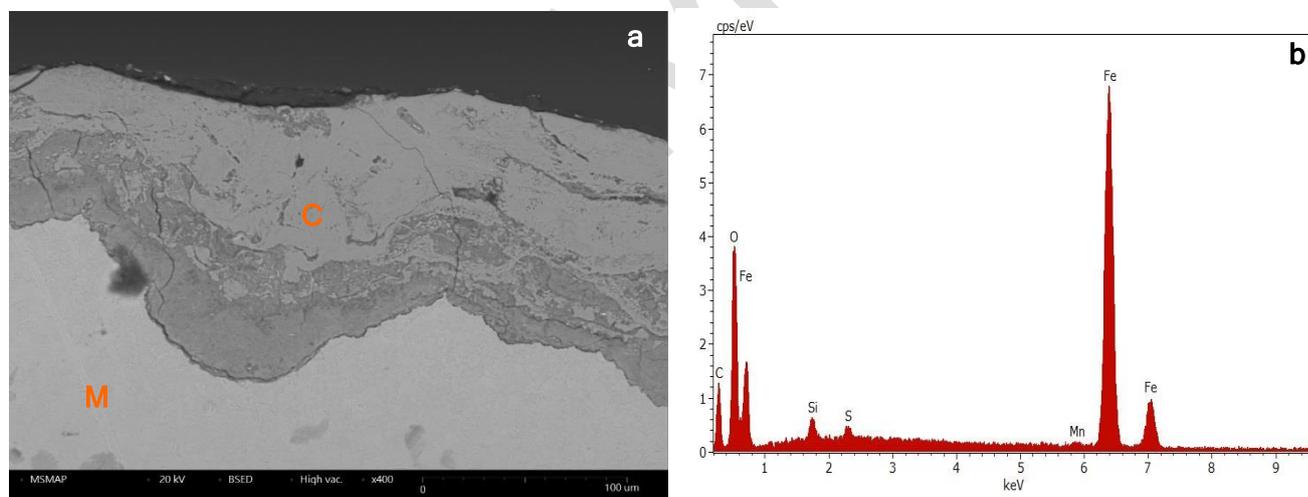
Figure 21: View of sample P1 (a-, SEM, BSE, x400) and EDX analysis spectra (b- and c-) of the corrosion products.

Corrosion (Fig. 21a, C) develops into the blade metal (Fig. 21a, M) and forms iron and iron-silicon oxide and hydroxides layered corrosion products from the steel (Fig. 21b and c).

The silicon level is variable and can be high (Fig. 21c).

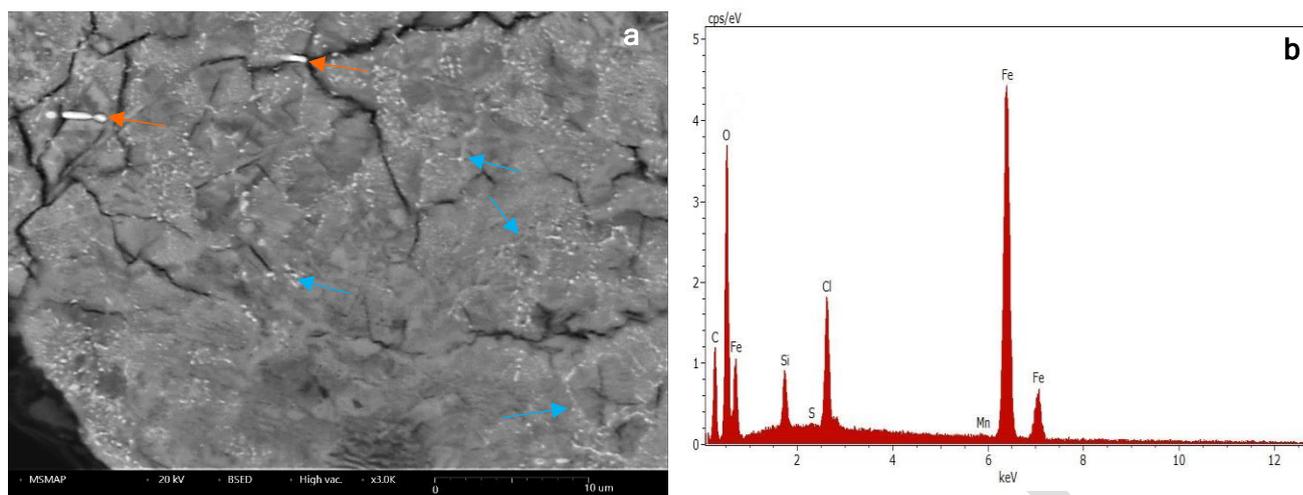
Figure 22: Detail view (a-, SEM, BSE, x3000) of the blade corrosion and EDX analysis spectrum of the steel corrosion products (b-) and of the elongated inclusion (c-). Sample C1.

Chlorine is also massively detected in some corrosion products (Fig. 22b).

In the corroded metal, where the ghost steel microstructure is still visible (Fig. 22a, blue arrows), elongated inclusions are observed (Fig. 22a, orange arrows). They correspond to elongated copper-enriched manganese sulphide inclusions present in the steel (see Fig. 11).

In the corroded area, there is a compositional change of the inclusions, for which iron and sulphur are still detected (Fig. 22c), but manganese is very low and copper is present (compare with the spectrum in Fig. 11a). Some mercury (Hg) is also detected.

The mercury observed in some inclusions (cf. Fig. 22c) could also originate from the object environment.

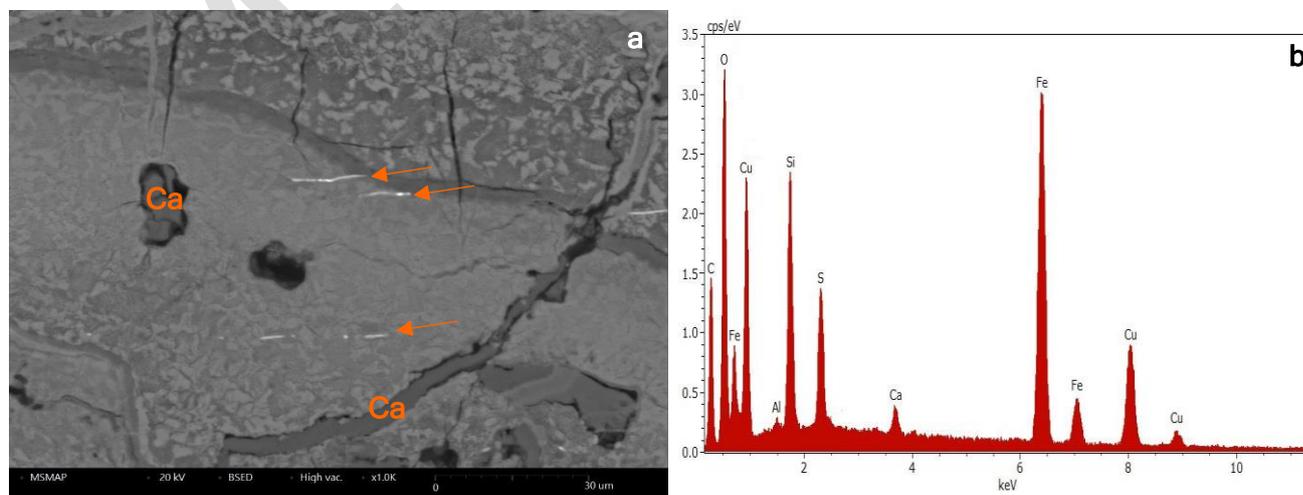
Figure 23: Detail view (a-, SEM, BSE, x1000) and EDX analysis spectrum of the corroded manganese sulphide inclusions. Sample C2.

In the outer part of the corroded metal, where the ghost microstructure has completely disappeared, the inclusions are still present (Fig. 23a, orange arrows), with the same compositional change, which corresponds to a leaching of the manganese (Fig. 23b) and a significant copper enrichment.

This phenomenon, corresponding to the alteration of the manganese sulphide inclusions to copper sulphide inclusions, is observed in steel corrosion (6).

The detection of calcium in some of the inclusions (Fig. 23b) is indicative of an exchange with the environment of the object, as some cracks or porosities, close to these inclusions contain crystallized calcium carbonate (Fig. 23a, **Ca**) that may only occur from the outside of the object.

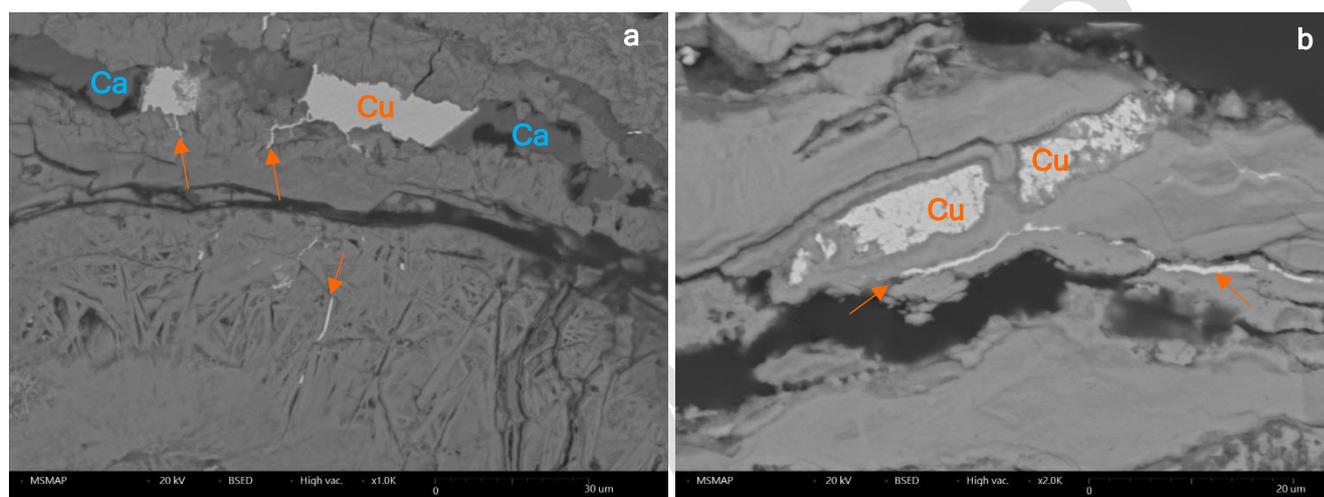
Figure 24: Detail views (SEM, BSE, **a-** x1000, **b-** x2000) and EDX analysis spectrum (**c-**) of the metallic copper recrystallization in the steel corrosion products.

In the outer rust layers, secondary metallic copper crystallizations (Fig. 24a and b, **Cu** and arrows and Fig. 24c) are observed in porosities, cracks of the corrosion layers, or voids between steel corrosion products crystallizations.

In the case of this object, the copper, sometimes observed with calcium carbonate (Fig. 24a and b, **Ca**) crystallizations in cracks filling is obviously of external origin and indicative of a long-term corrosion in a humid environment.

Here, the copper could originate from the corrosion of the hilt - or from a now disappeared scabbard or from abundant copper in the burying environment (proximity with a corroded copper alloy object).
