Laboratoire M.S.M.A.P. SARL

STUDY OF A SWORD WITH GOLD INLAID INSCRIPTION (L.: 57 cm)

Assumed provenance and period: Khorasan, Samanid, 9th -10th century AD.

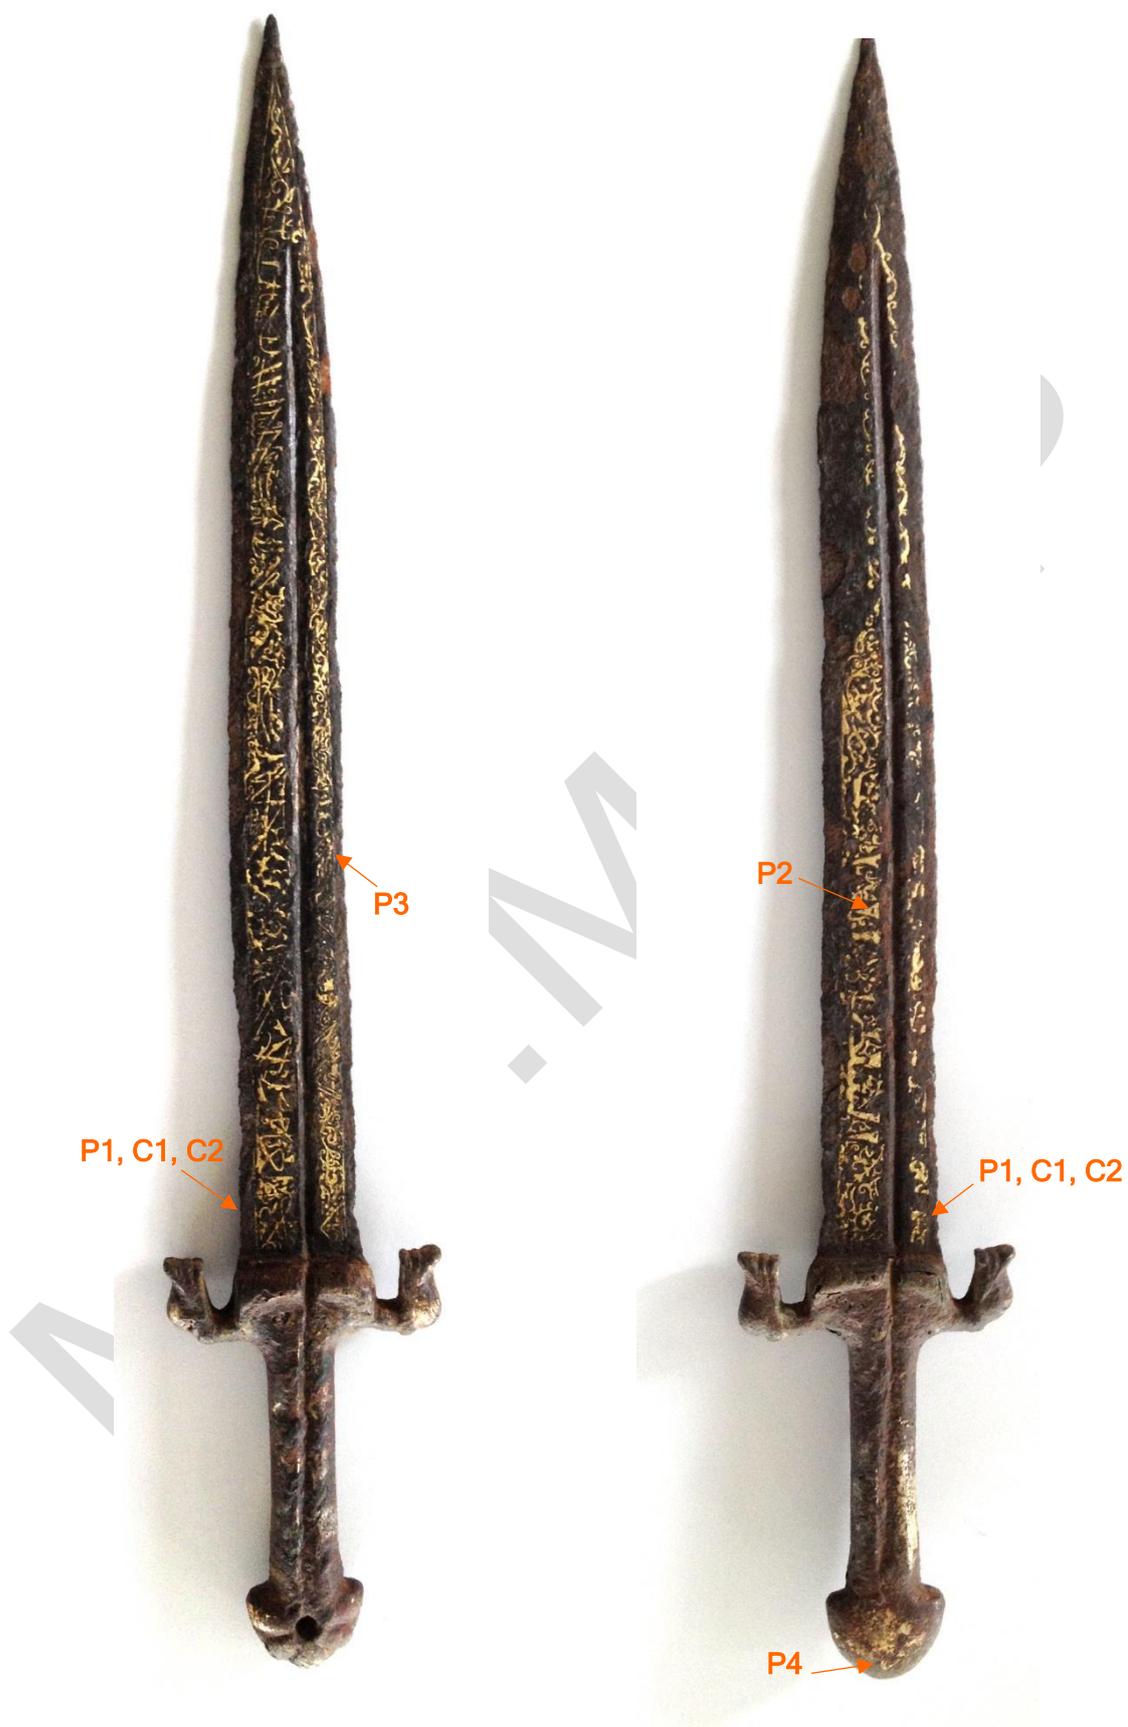
Figure 1. Overall views of the sword and samples localization.
